Tanvir Tanim, Senior R&D Scientist and Group Lead  
Energy Storage Technology Group, U.S. Department of Energy  
Energy Storage and Electric Transportation

# A Teardown Study of Flood Damaged Electric Vehicles

EV Battery Safety, Part 2

SAE Government/Industry Meeting  
January 16-18, 2024, Washington, DC, USA

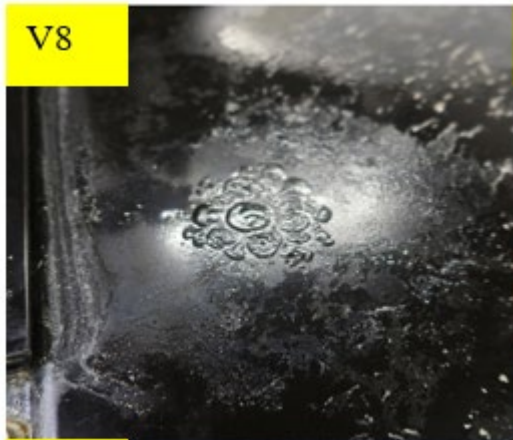
Battery lid surface

- Distinct corrosion was observed throughout the vehicles where salty or brackish water submersion was present:
  - This includes the metal frames, battery pack exterior, LV systems and harnesses, HV charging connectors, fasteners, etc.

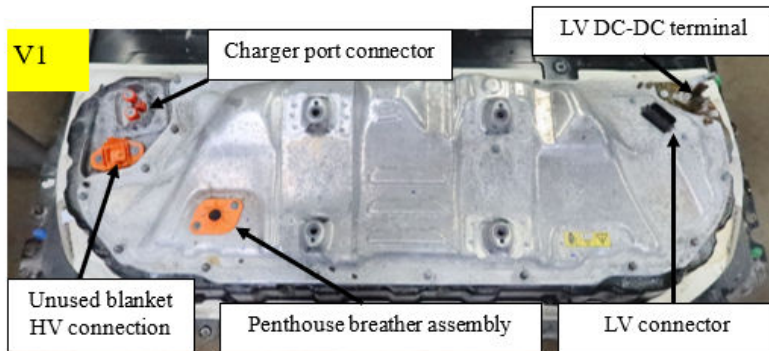
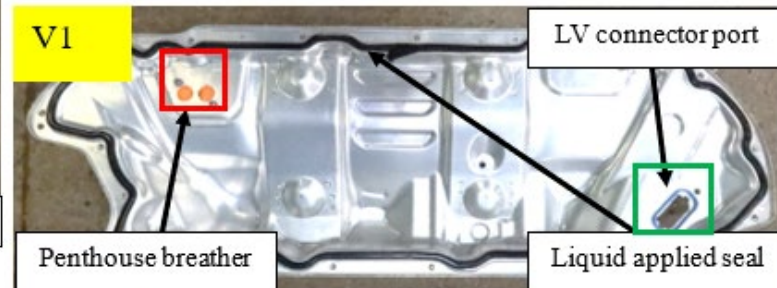
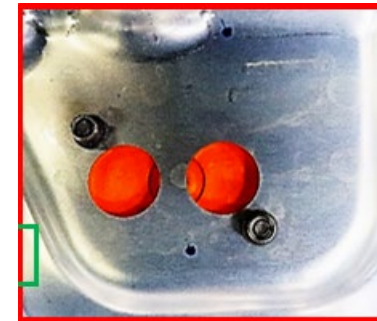
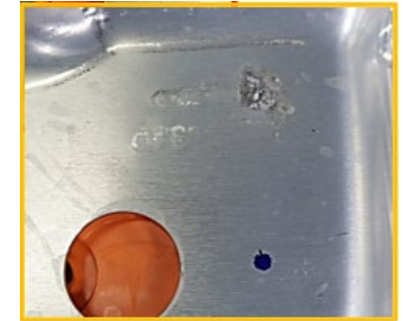
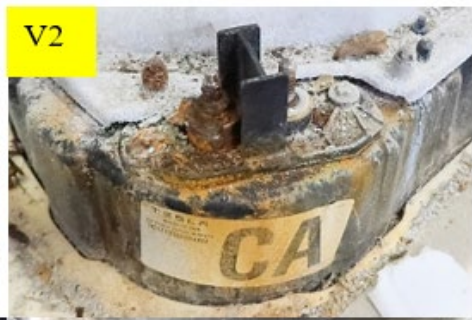
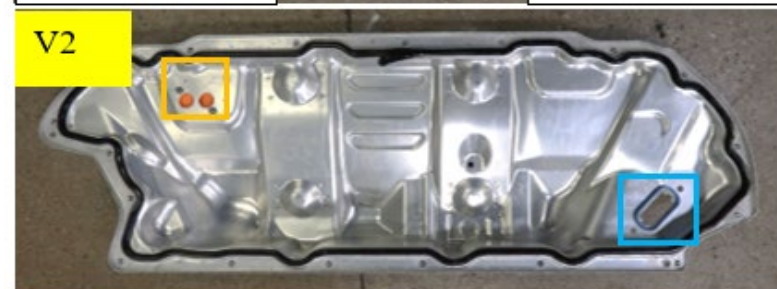
- The exterior side of the penthouse shows signs of submersion resulting in various levels of corrosion for all four EVs in this design group.
- The low voltage DC-DC converter terminals are exposed on the penthouse and as a result exhibited particularly severe corrosion resulting from galvanic activity.
- The underside of the penthouse lid shows what appears to be residue of dried liquid in two distinct areas, which may be indicative of either condensation or some level of water ingress in V1 and V2.
- Those areas are surrounding or adjacent to the penthouse breather vent and low voltage communication connector.
  - The interior surroundings of the low voltage connector opening (silicone seal) in V2 shows witness marks.

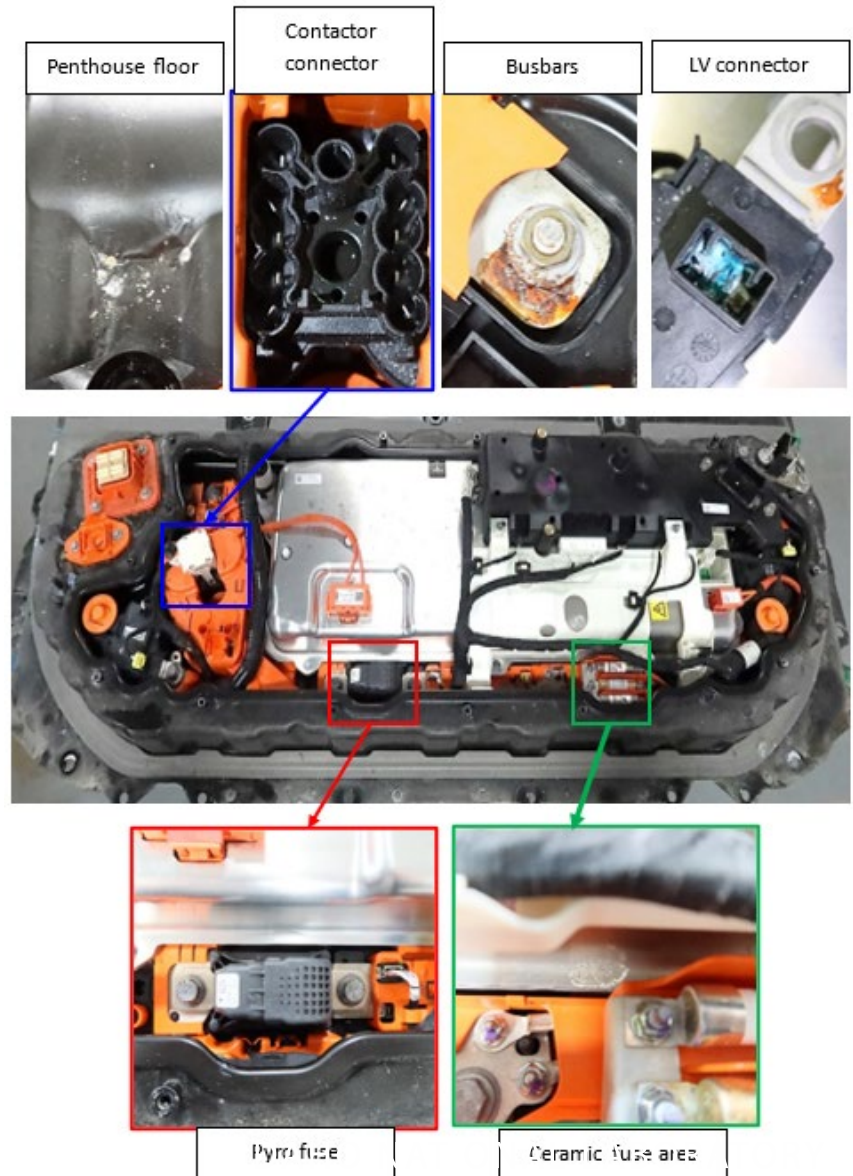
- Distinct corrosion, contamination, water, and water marks on the floor of the penthouse and within several components for V3 (Tesla Model 3) were observed:
  - More specifically, corrosion was noted on the busbar connections, within connectors, on the uncoated aluminum housing of the charger/inverter module, and elsewhere
  - Contactors tested the open-circuit (normal) and found the pyro-fuse had not triggered.
- In this state, it is highly likely that the modules within the penthouse would be unable to function properly in any capacity.

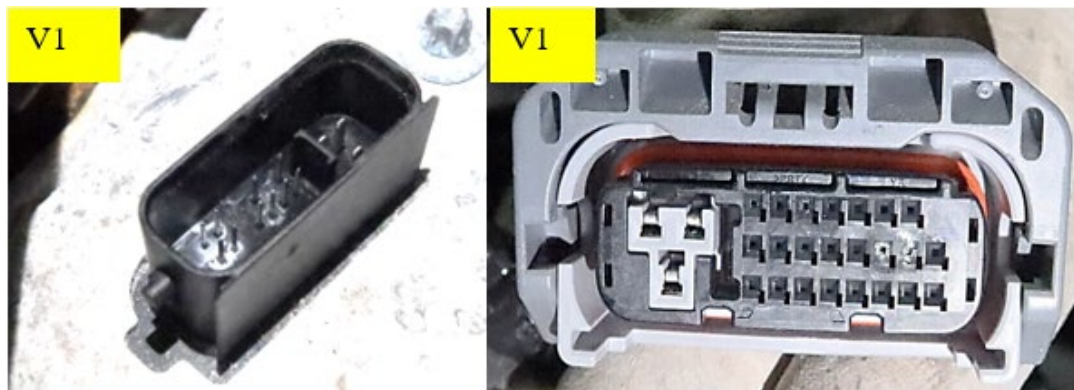
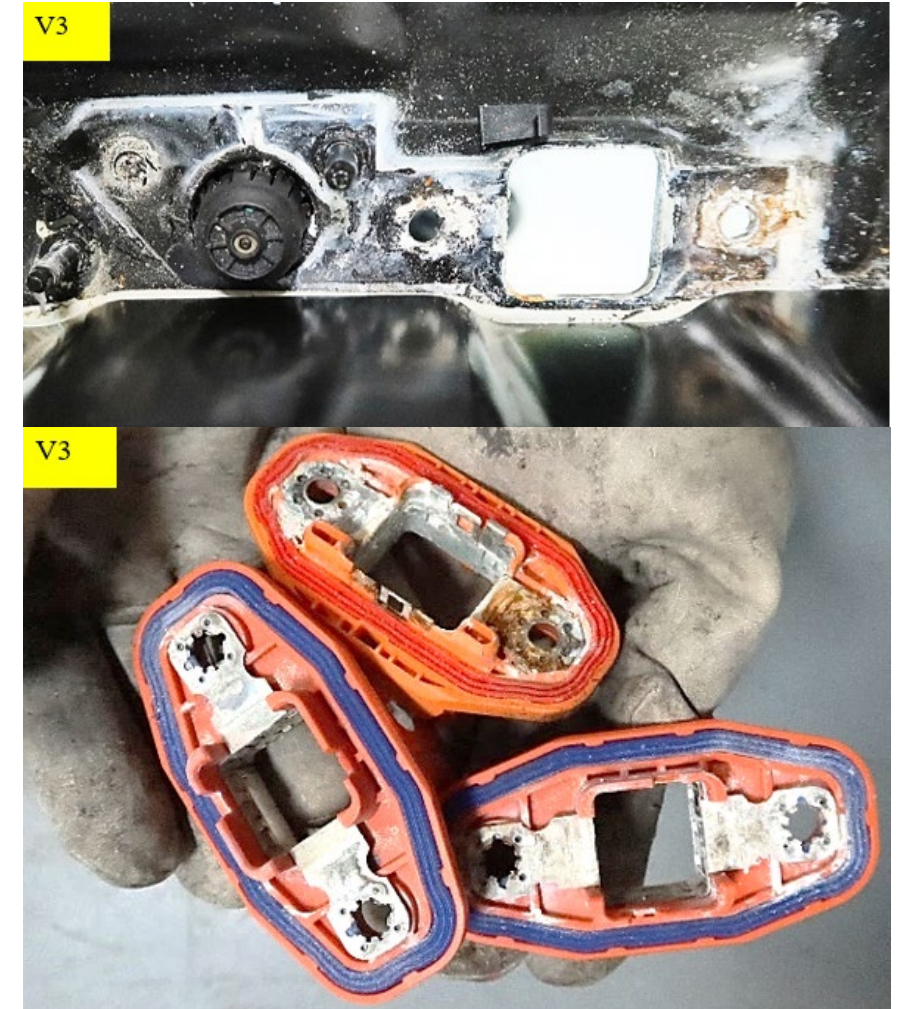
- For V3 (Tesla Model 3), the high voltage connectors of the electronics penthouse were observed to have a high degree of corrosion throughout. The internal surface of the pack where the connectors mount also showed a large amount of contamination.
- The interior, sealed area of the low voltage communication connector on the penthouse of V1 (Tesla Model Y) exhibited what appears to be the dried residue of water intrusion and remnants of light corrosion or contamination surrounding the bases of several pins. Similar corrosion was found on the corresponding terminals of the vehicle wire harness.

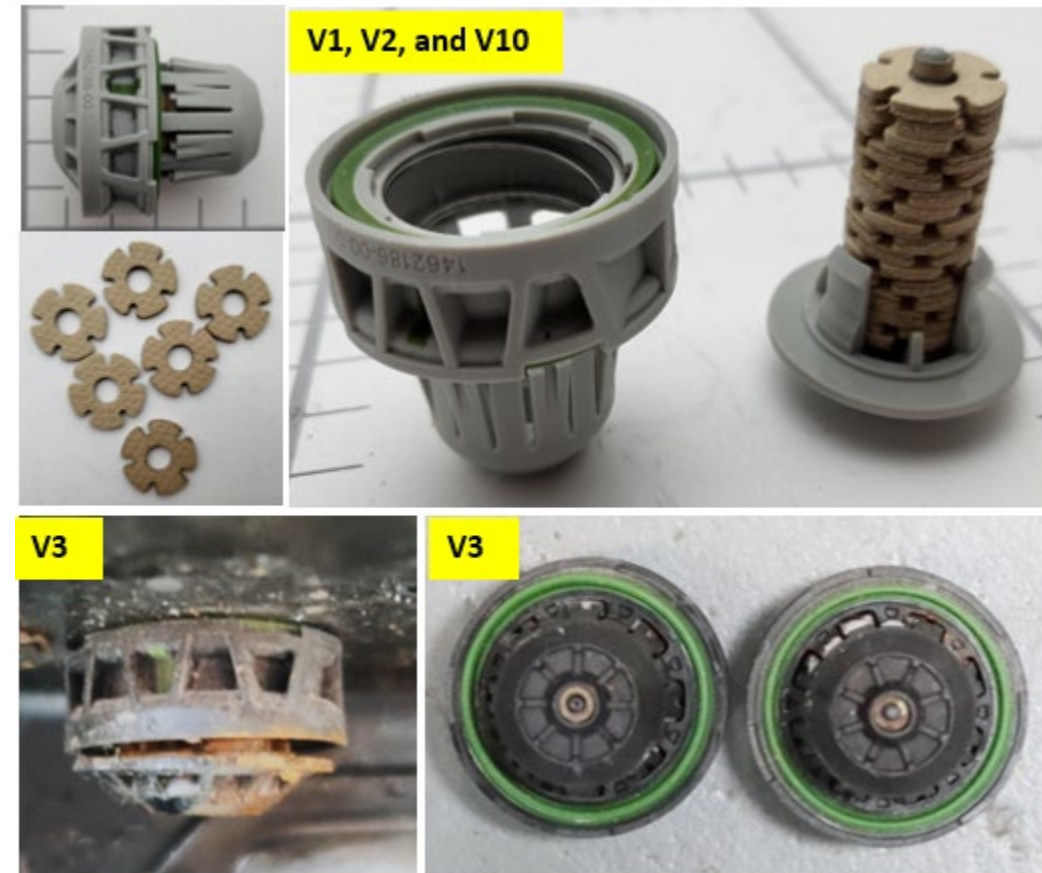
- Two moisture-activated vents, or “flood ports,” as Tesla calls them, are located on the rear right and left sides of the battery pack, mounting through the bottom of the tray into the interior of the penthouse compartment:
  - Cellulose-based wafers are stacked around a central shaft held closed by a spring and will expand in the presence of moisture, compressing the spring and opening the vent.
- For V3 (Tesla Model 3), both vents are observed to have activated and stuck open. While it is difficult to determine if these vents failed in some way and allowed water intrusion into the penthouse space, or if they merely operated as intended and only opened due to exposure to water within the penthouse from another source, they do present a possible point of ingress if at least one of the two are either defective or activated due to exposure to water from outside the pack.

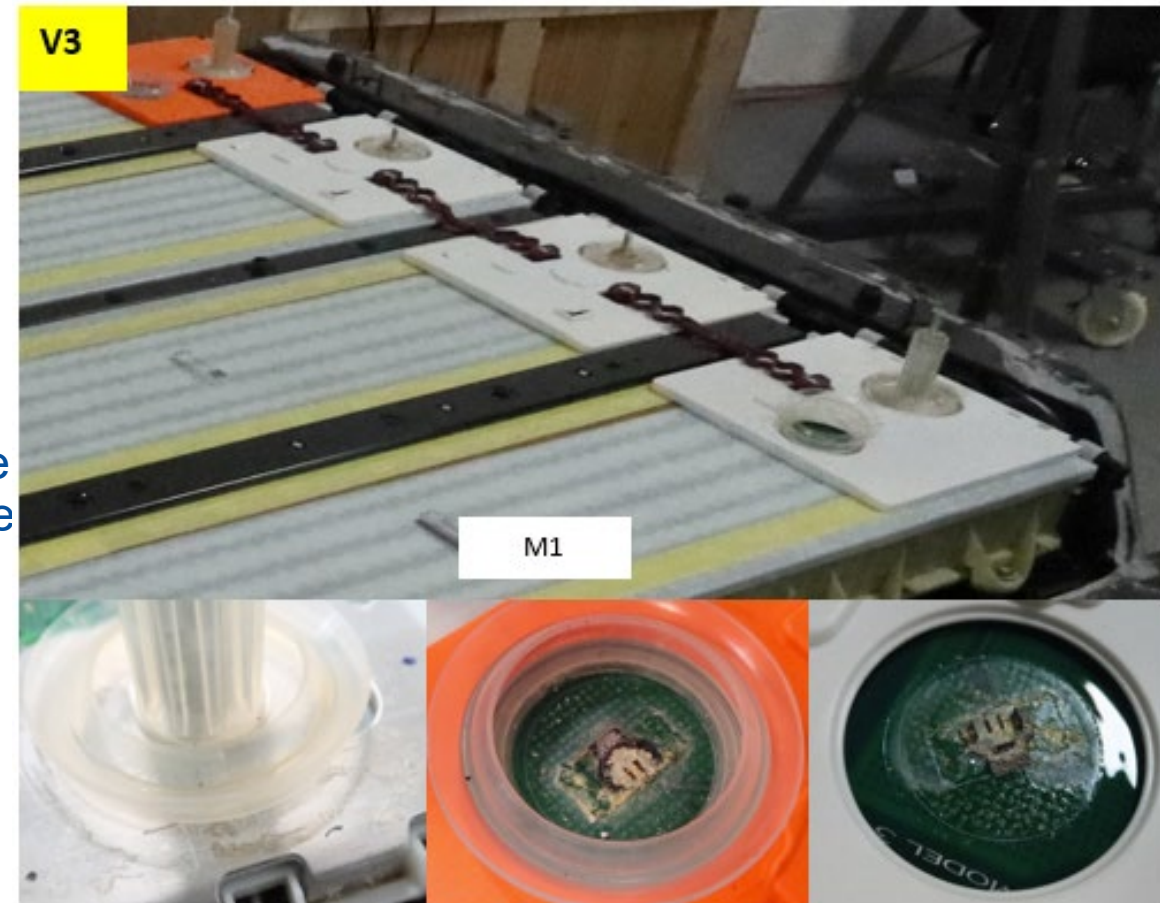
- The areas on the tops of the modules that interface with the electronics penthouse feature **circular gaskets** for sealing between the penthouse and the module space.
- Corrosion and contamination were observed on the surfaces of these sealed areas that are exposed to the penthouse space of V3 (Tesla Model 3).
- One of the gaskets appears to have failed, with some surface corrosion noted around the terminal bus plate of Module 1.
- While 7 out of 8 of the Tesla gaskets presented no apparent failure and the single gasket that failed had limited impact and occurred on a module that did not appear to present any issues, it is very possible that the exposure and corrosion on the BMS circuit board has incurred some form of damage that would negatively impact their function.

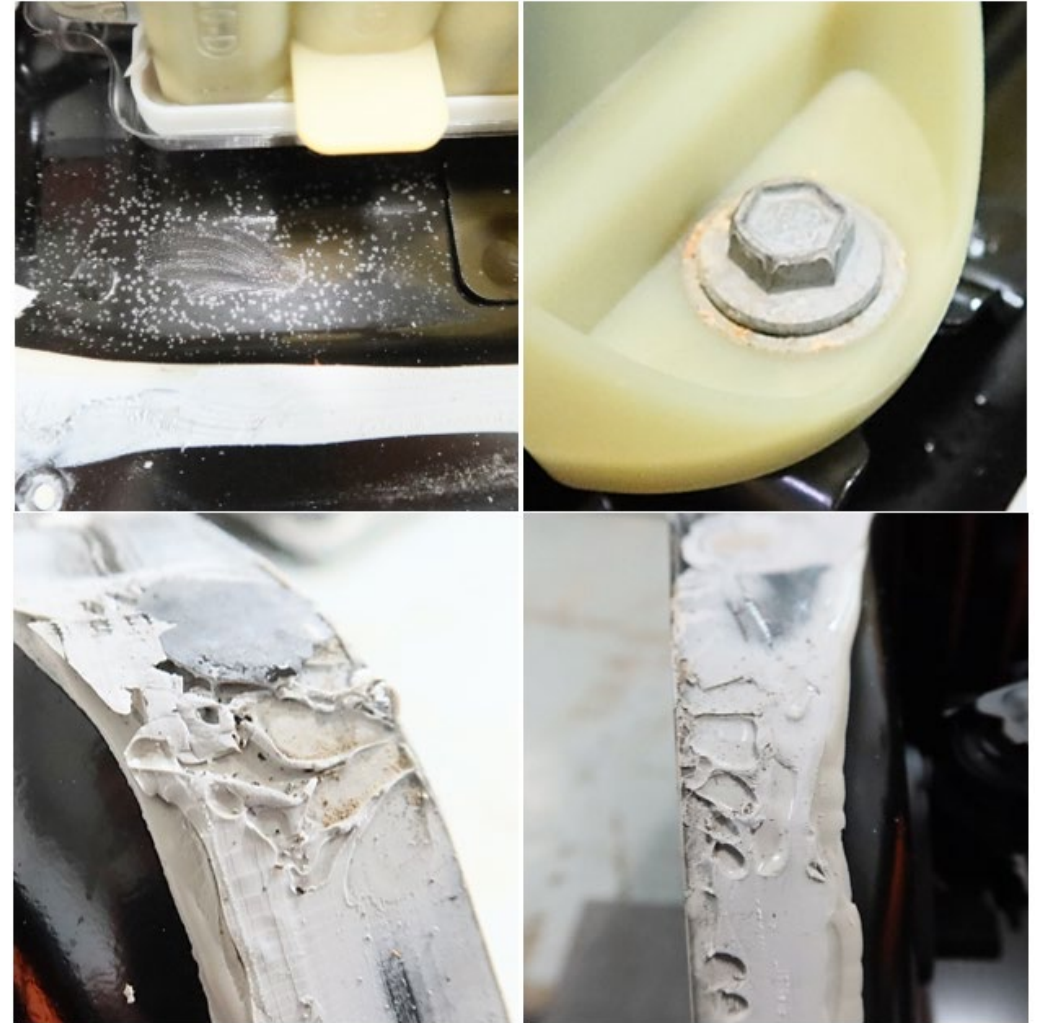
- Water, residue, and contaminants were observed on the pack floor under Module #4 of V10 (Model 3). This water and contaminate intrusion did not appear to contact the cells at any point, though the lower outboard mount fasteners of the module exhibited light corrosion.
- The apparent point of ingress was determined to be a void or gap in the liquid-applied lid perimeter seal at a complex curve near the front-right corner, possibly due to trapped air and/or inadequate clamping load prior to curing of the seal.

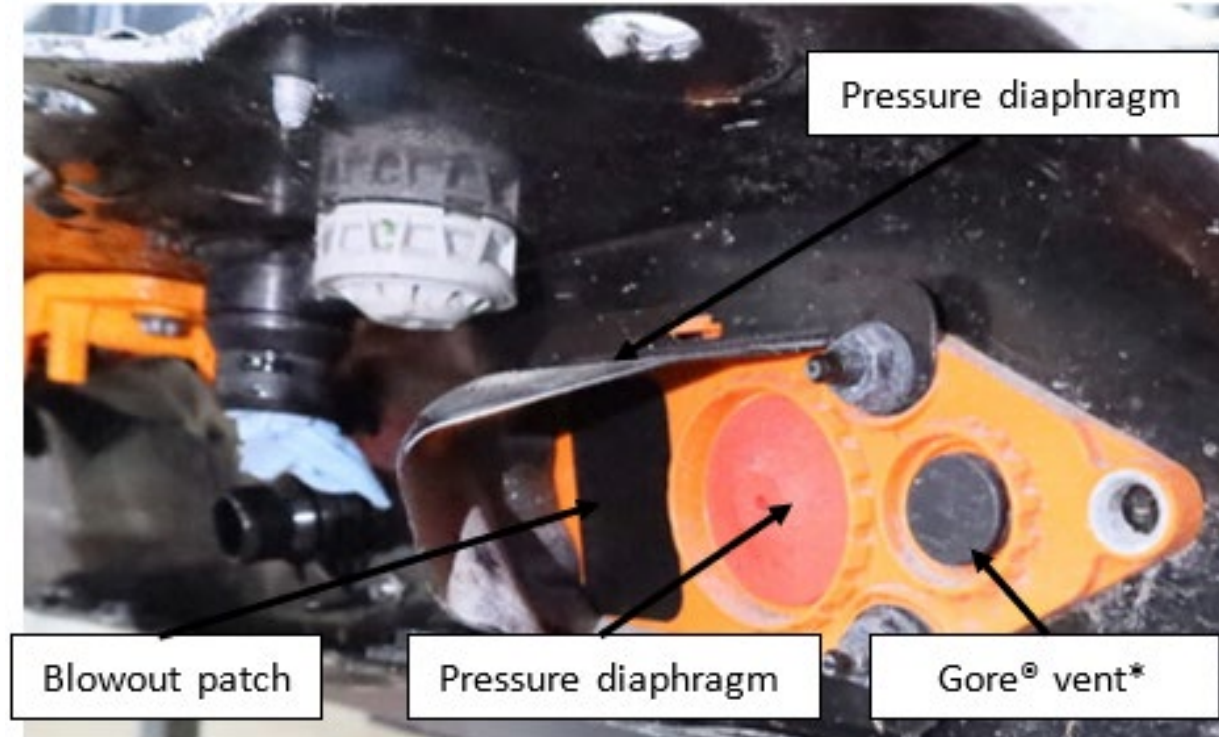
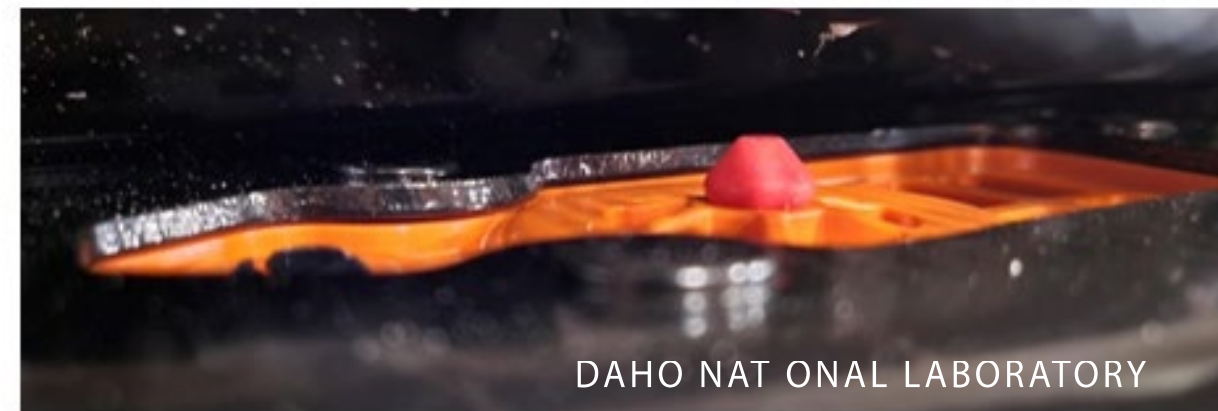
- Examination of the exterior and interior of the vent assemblies for all the vehicles in this design group shows no signs of seal failure or water ingress through the pressure diaphragm.

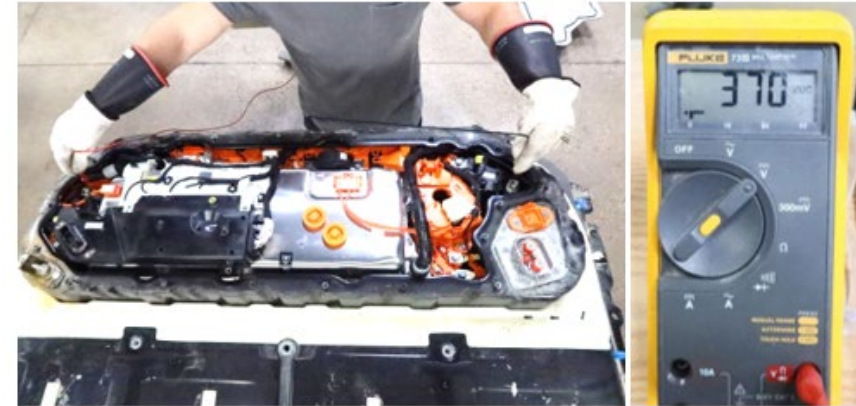
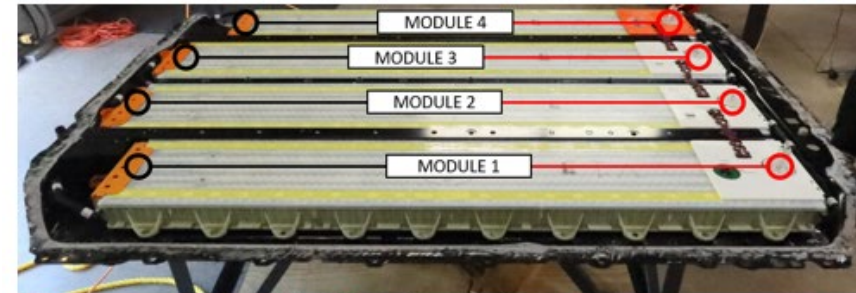
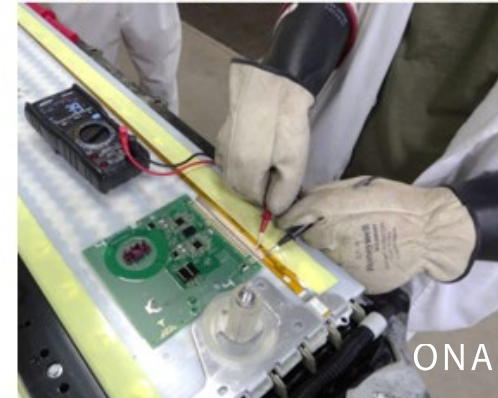
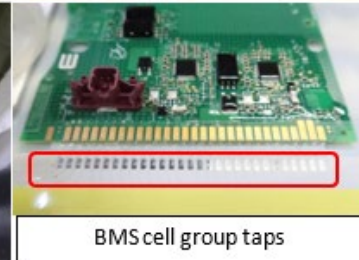
- In general, the pack voltage remains elevated even after more than ten months of storage:
  - Except for V3 (Model 3), the maximum cell group voltage variation remained within 14 mV.
- The Module 3 of V3 measured 3V lower than the identical Module 2. Cell group voltage testing revealed cell group 11 within Module 3 measured 1.06V vs the average cell group voltage of approximately 4.00V.
  - The over-discharged cell group was consequently located, and surrounding materials were removed, and no evidence of any physical damage or watermark was found. The absence of any evidence of water induced damage indicates manufacturing/aging related issues within cell Group 11 that became pronounced when the BMS balancing system was non-operational upon failure of the 12V system.

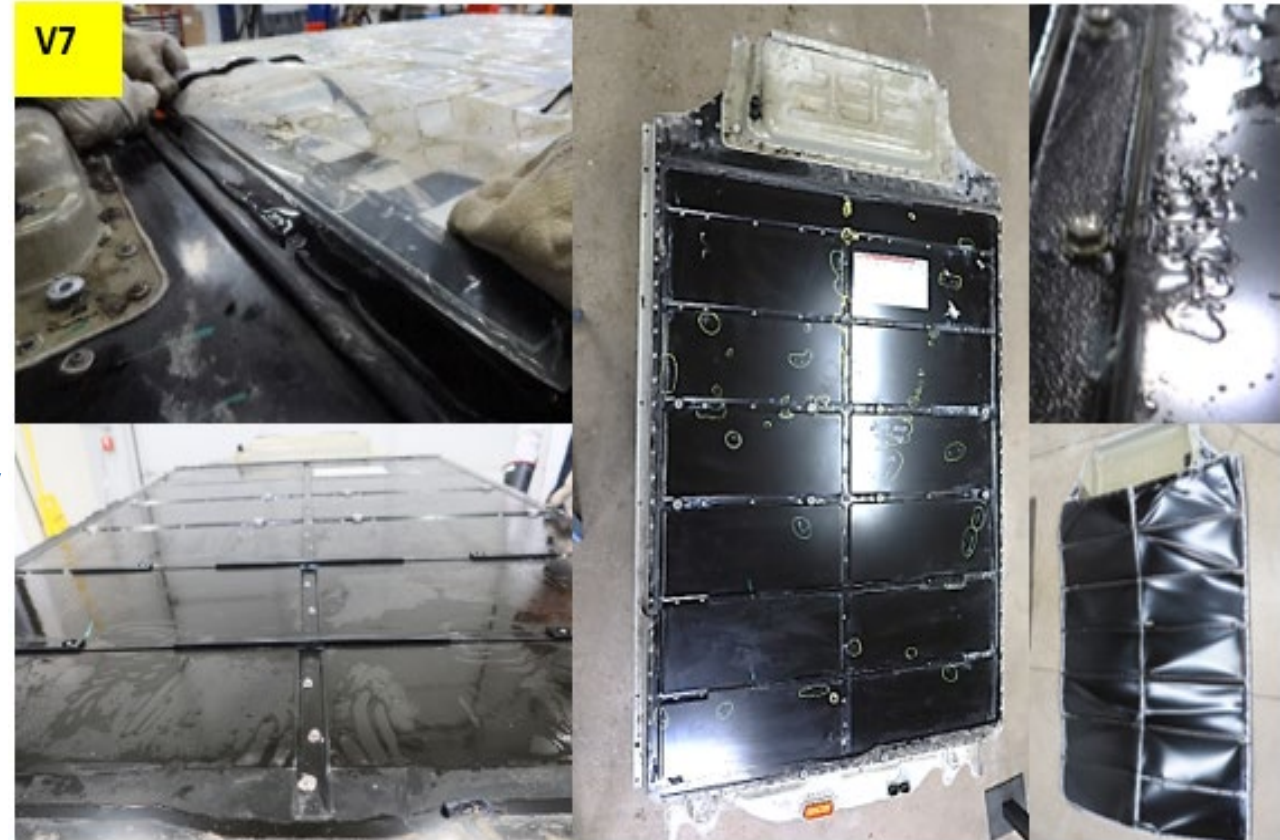
- For V6, the plastic sheet was able to retain its integrity. The plastic sheet in the remaining vehicle packs (V7-V9) failed to retain integrity:
  - Standing water was evident on the pack exterior both on top of and underneath the plastic sheet on the lid. Adhesive beads were penetrated by water in at least one area thereby allowing water across the barrier. A multitude of areas with corrosion/failed environmental coating were noted across the entirety of the lid exterior, evidenced by “bubbling” of the lid coating, and most likely caused by the trapped water compromising the coating. This corrosion also extended to several fasteners exhibiting a rusty appearance.
- Despite the numerous areas showing corrosion, the interior-facing underside of the lid exhibited no signs of corrosion, contamination, or damage and the pack interior likewise had no evidence of such.

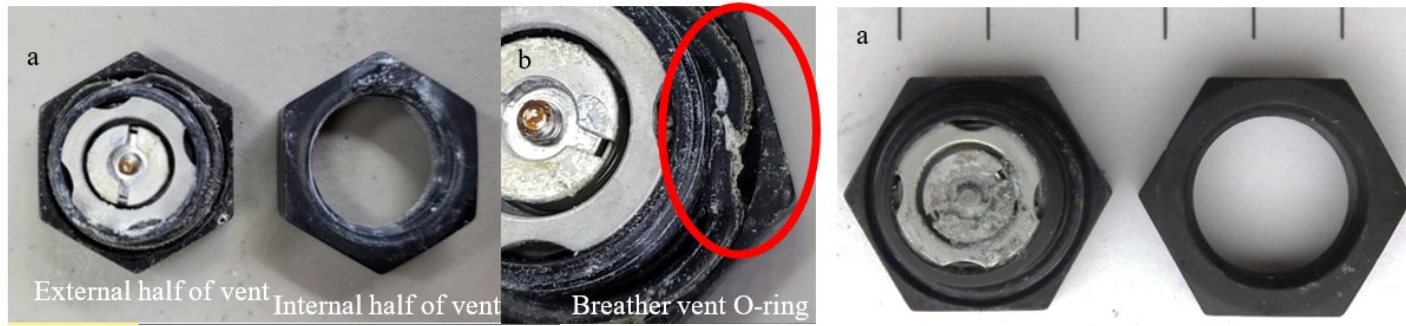
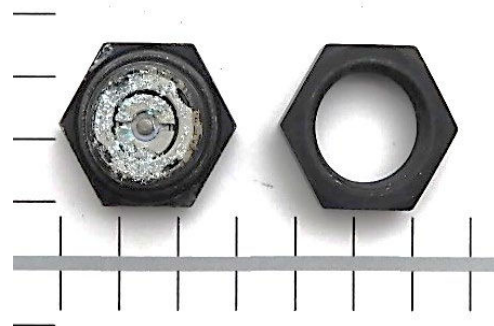
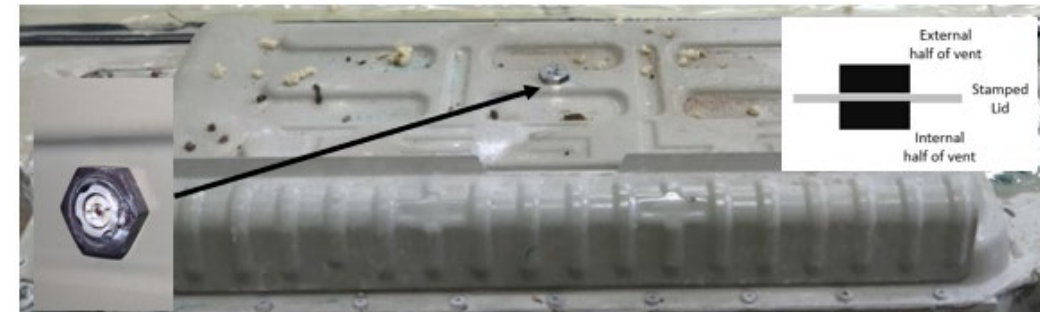
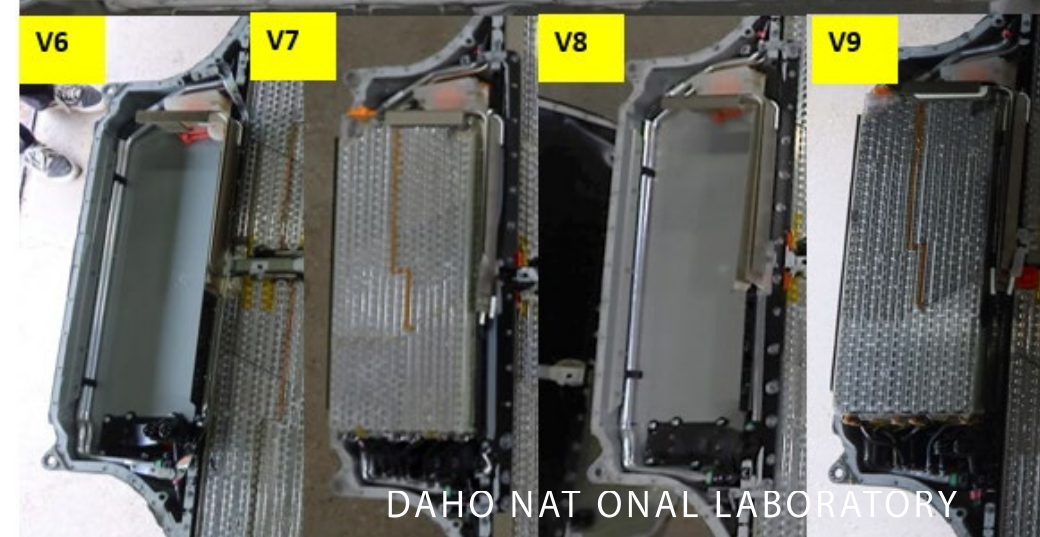
- There is a mechanical breather vent located on the lid in the center of the penthouse of V6 (Model X), V8 (Model X), and V9 (Model S). Vehicle V7 (Model X) did not have a breather vent.
- Water ingress and contaminants were observed in the floor of the penthouse space of V6, V8, V9, directly below the breather vent on the lid due to its failure:
  - Modes of vent failure: Compromised section of the O-ring (V6), internal failure (V8 and V9).

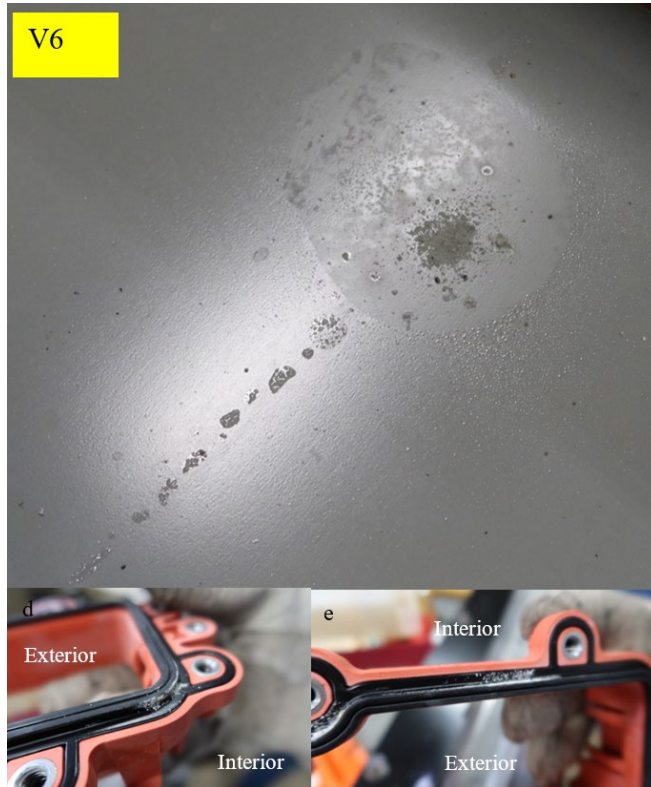
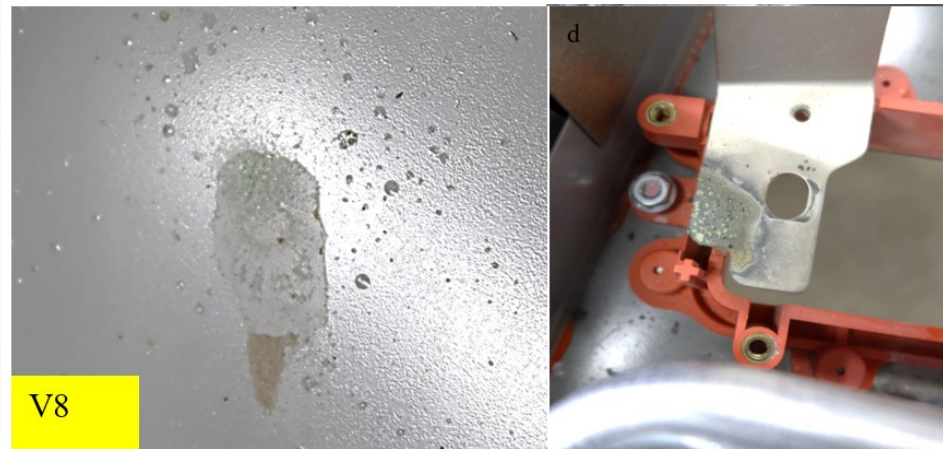
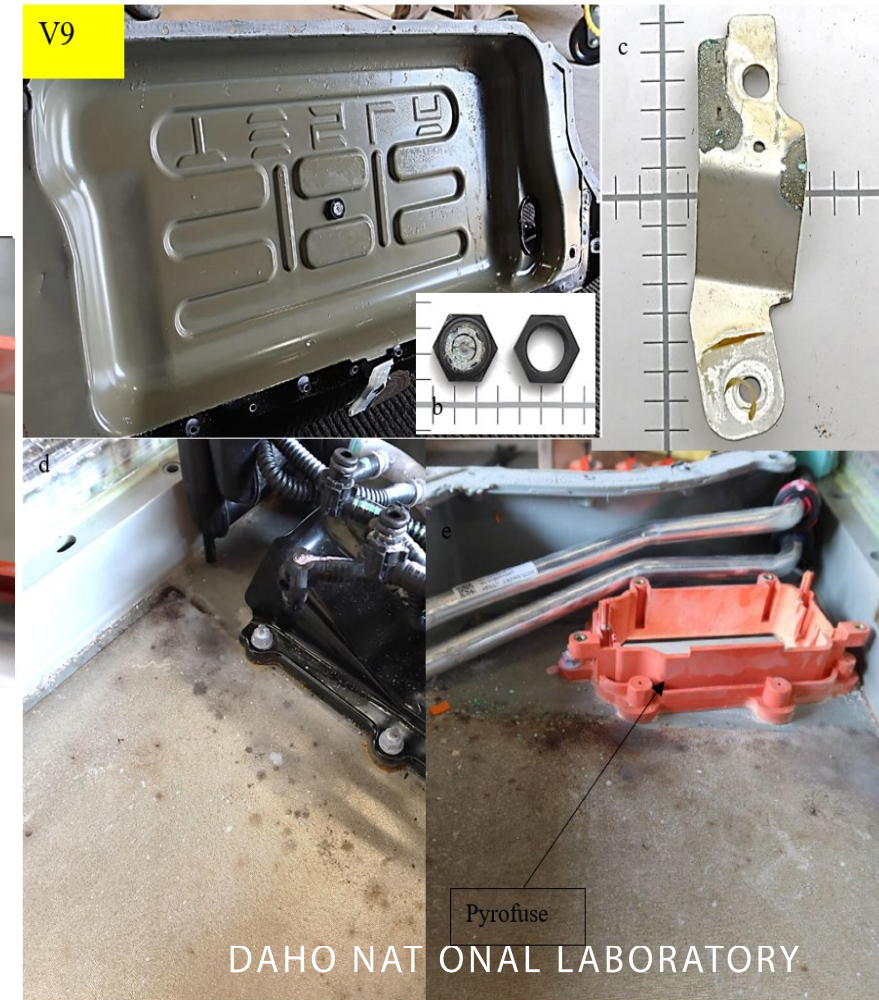
- Pictures showing evidence of watermark/sediments, condensation, corrosion, and mold growth.
- V9 pack had water condensation throughout the pack, resulted in distinct corrosion.

The presence of sediment deposits exclusively on the interior side of the pyrotechnic fuse, suggesting that the source of the liquid that encountered the seal is somewhere inside the pack penthouse.

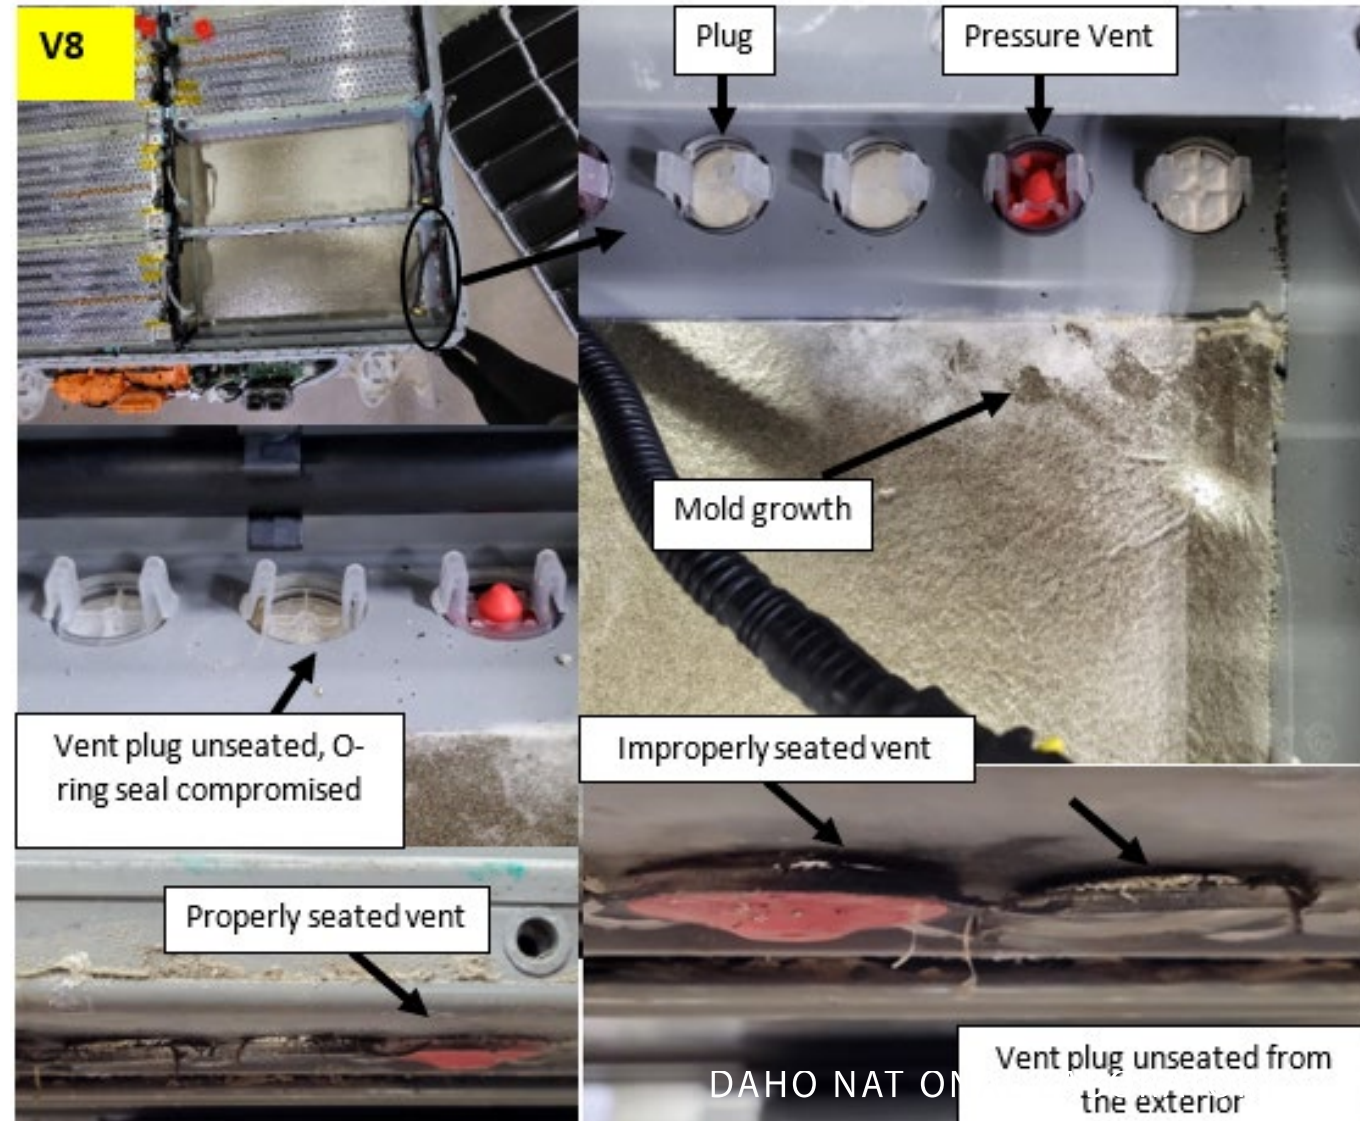
- The side sills of the battery pack for this design group feature snap-in pressure vents and vent hole plugs, each of which seal against the battery pack tray with an O-ring:
  - Close examination of the interior side of the vents revealed certain instances where the retaining features of the snap-in vent bodies had failed, resulting in the vent or vent plug becoming unseated in its hole, thereby compromising the integrity of the O-ring and allowing water ingress
  - Not every component had been unseated from the interior as shown in the figure, rather the exterior faces of the other compromised vents revealed slight misalignment that may have contributed to a compromised O-ring seal.

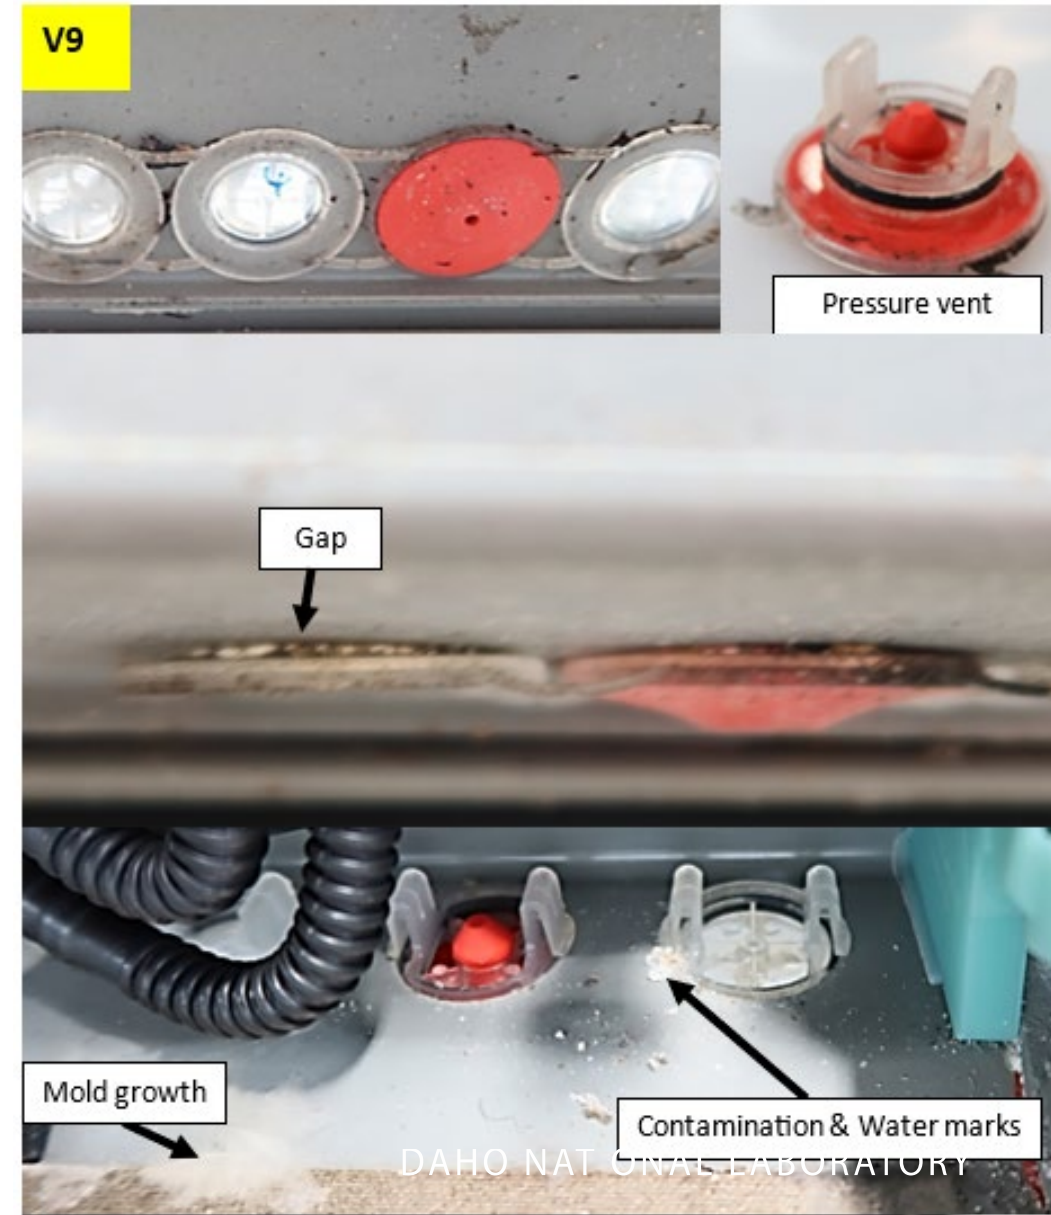
- For vehicle V9 (Model S), every module space within the battery pack displayed signs of water contamination – water, water marks, sediment/residue, and/or mold:
  - These vents and plugs showed varying degrees of evidence of contamination and may be a primary source of water intrusion within the non-penthouse area of the pack of V9.
- For V6 and V7, the plugs and vents were uncompromised.

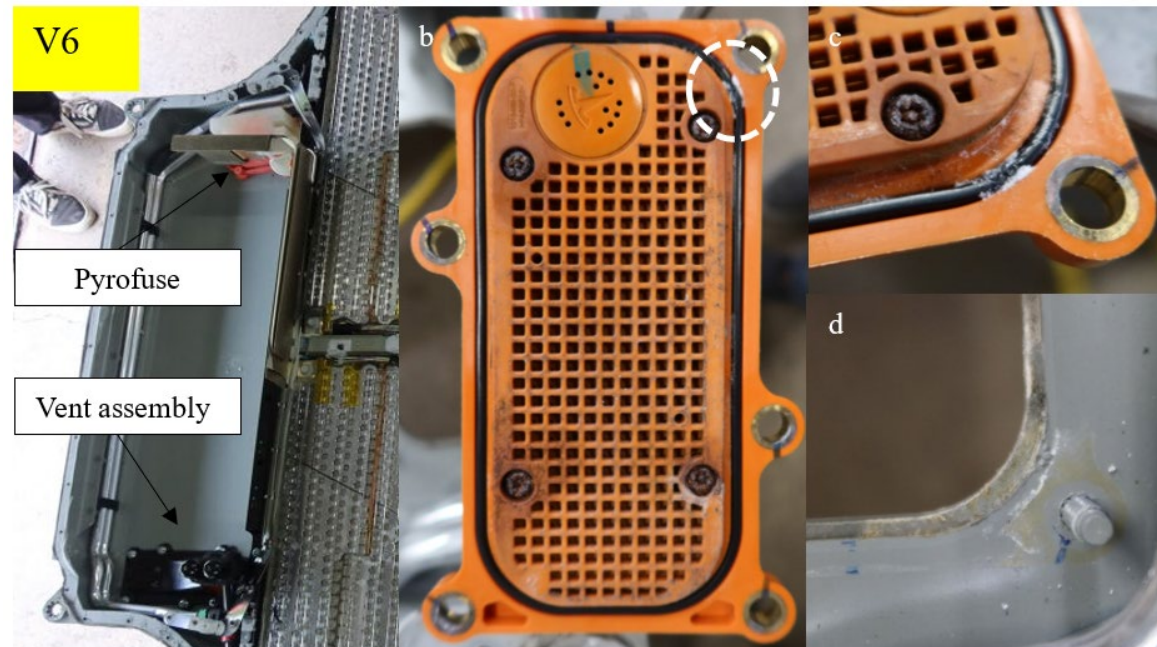
- Upon removal of the vent of V6 (Model X), sediment deposits were observed in a localized area of the injection molded seal:
  - The sediment was present on both sides of the seal.
  - Given the proximity of the breach to exclusively one of the studs used to fasten the vent to the pack, it is possible that insufficient fastener torque resulted in a local reduction in compressive force on the seal, causing this localized leak.
  - The vent assembly of vehicles V7, V8 and V9 is found to be uncompromised.

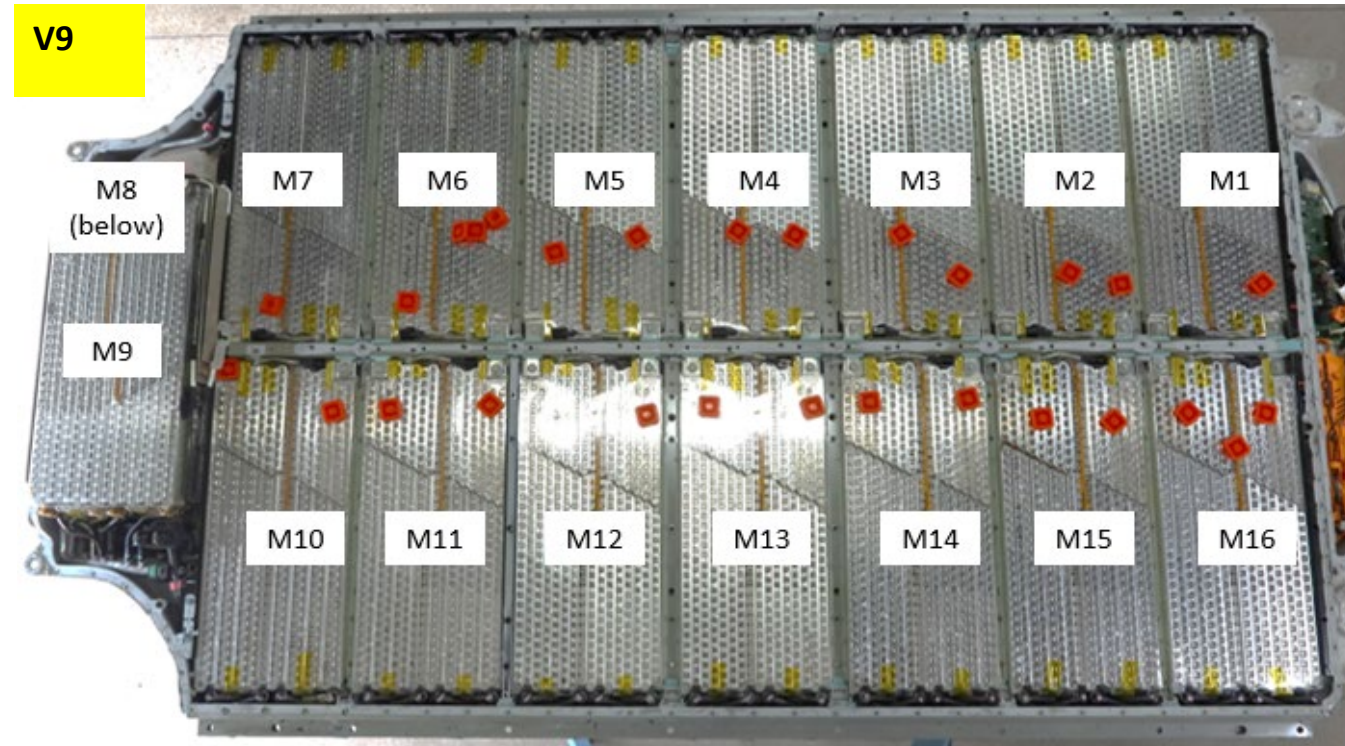
- Unlike Pack Design 1, which had four larger modules, Pack Design 4 consists of up to 16 smaller modules:
  - For V6 (Model X), V7 (Model X) and V8 (Model X), the module voltages were consistent, deviating by at most 0.18V (max-min module voltage) or 44.5 mV 1 $\sigma$  standard deviation
  - For V9 (Model S), voltage of Module M8 (located underneath module M9) measured to be 0.44V, and hence created a wider spread (24.12V) and standard deviation (5.83V).

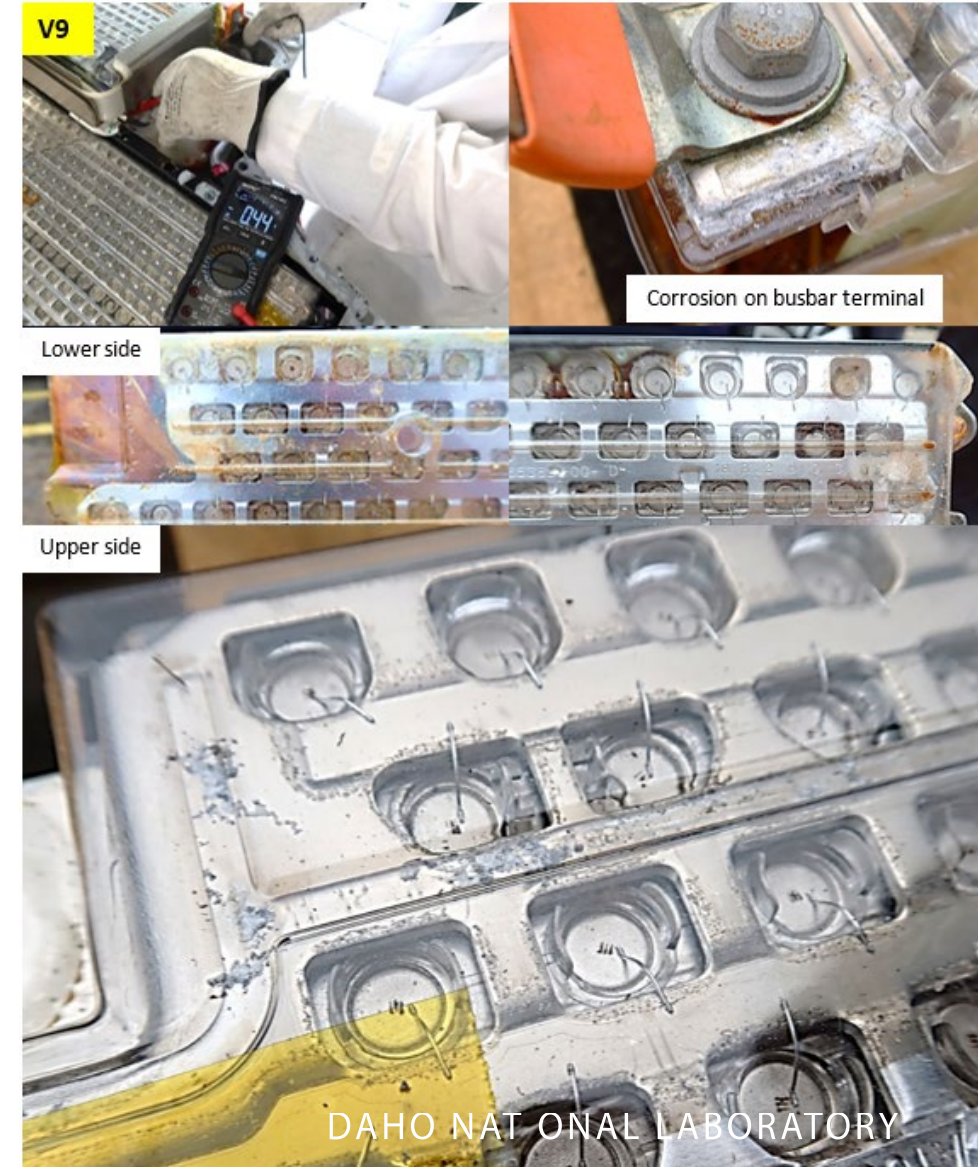
- Both Modules M8 and M9 were located directly underneath the penthouse breather vent that failed:
  - The lower battery module, M8, within the penthouse and measuring a mere 0.4V shows evidence of prolonged and severe water contamination, as indicated by large amounts of corrosion and residue throughout the module. Hence, Module M8 may be nonfunctional, unsafe, and completely unsuited for operation

- The source of the water exposed to this module would appear to be the breather vent on the top of the penthouse lid, which sits directly above both M8 and M9. Given that M8 is located at the bottom of the pack, water likely collected and caused the short which discharged the module. Though also contaminated and corroded, the upper module, M9, voltage measured in line with the remainder of the modules, therefore, it is presumed the water intrusion flowed over the upper module and left it unaffected in comparison to the lower module, which dwelled in the accumulated water.
