Tanvir Tanim, Senior R&D Scientist and Group Lead  
Energy Storage Technology Group, U.S. Department of Energy  
Energy Storage and Electric Transportation

# A Teardown Study of Flood Damaged Electric Vehicles

EV Battery Safety, Part 2

SAE Government/Industry Meeting  
January 16-18, 2024, Washington, DC, USA

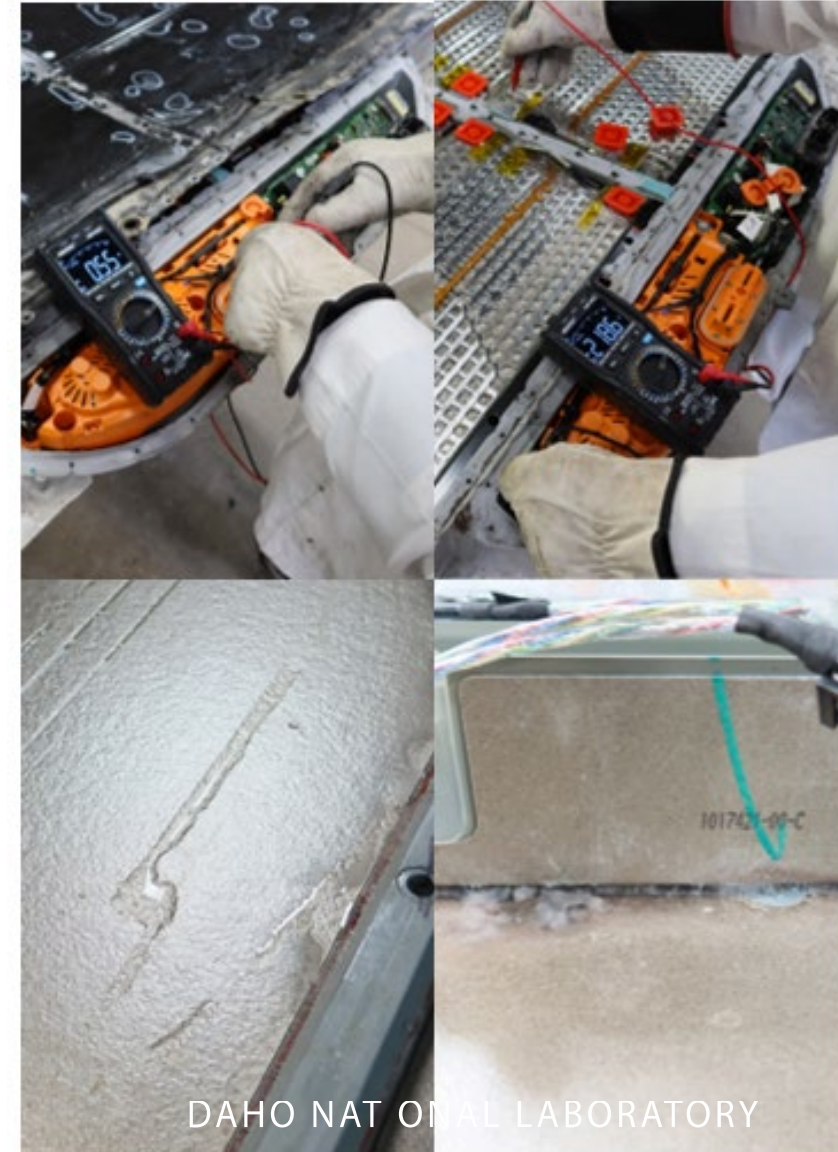
- Isolation fault within the battery of V9 (Model S):
  - While testing for isolation faults by measuring HV connector and module-to-chassis voltages, various abnormal results were observed. These were: (i) a voltage of 0.55V between the external high voltage terminals with contactors open, (ii) a voltage measurement of 218.6V, between battery module M1 to the battery chassis prior to busbar removal, and (iii) 3 to 9V from individual modules to battery chassis after busbars had been removed.

- The apparent source of the isolation fault appears to be contamination on underside of modules – even with all busbars disconnected and removed, voltage/continuity between module terminals/current collectors and battery chassis was observed.

- The front of the pack uses aluminum tubing to carry ethylene glycol coolant to the main inlet/outlet ports on the pack lid. Corrosion/crystalline material was observed on the aluminum tubes which contacted the pack tray.

- Current hypothesis is that the electrolyte degraded the adhesive layer between the battery cells and cooling channel, thereby enabling electrical conductivity from the cells through the cooling channels and the coolant fluid itself to the pack chassis.

These isolation faults were deemed to be of sufficiently high enough resistance to be deemed safe, and probably not in violation of FMVSS-305 (>500 Ohms/Volt).

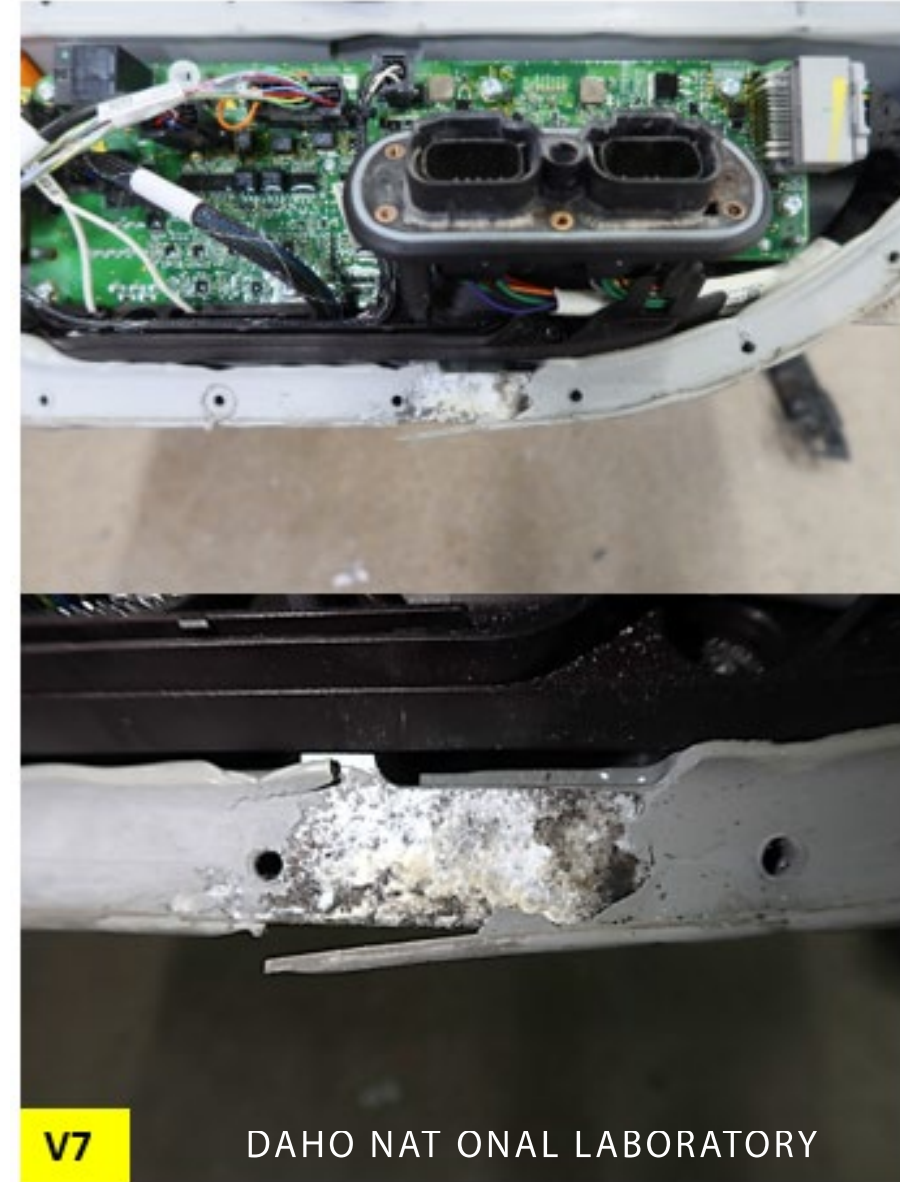
- Upon removal of the power distribution lid, a portion of the sealant bead remained adhered to the lid and exposed an area of corrosion on the mating surface of the tray structure.
- Although spanning the full width of the mating surface, no evidence of water intrusion or corrosion was observed on or below the power distribution components.
- It is most probable that at an undetermined point in time (most likely during the flood event) the coating of the tray structure adjacent to this sealing surface became damaged and then allowed corrosion to begin, progress, and creep under the sealant bead, eventually compromising the complete width of the sealing surface.
- Due to the lack of corrosion or contamination within the interior space, it is most likely that the corrosion progressed AFTER the flood and during storage at a vehicle scrap yard.

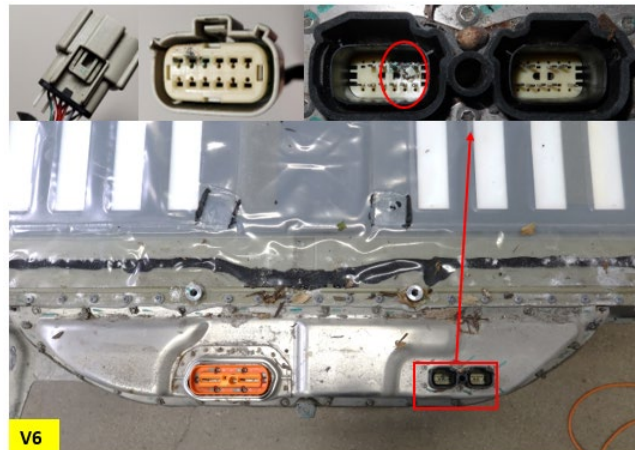
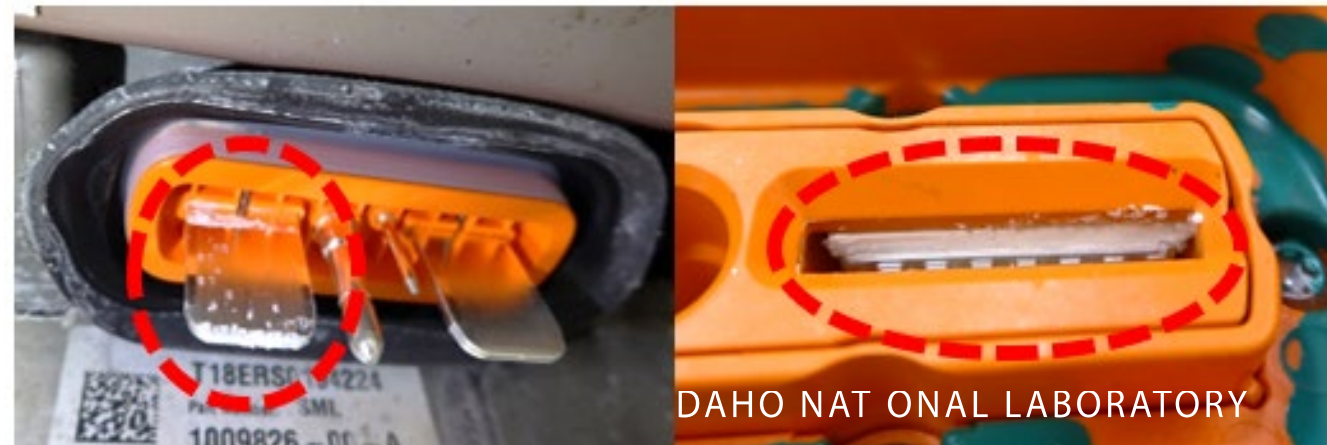
- Upon examination of the low voltage connectors after dropping the pack, significant corrosion was noted around several pins in addition to one of the pins having been broken off in the corresponding female body-side connector:
  - The lack of a snap-fit mechanism to ensure proper installation depth of the low voltage connector is likely the mechanism by which the water was able to enter the connector and cause the observed corrosion on the pins and terminals.
- Corrosion was noted inside one of the battery pack high voltage terminals upon removal from the vehicle. The corroded terminal blade displayed white deposits around the base where it protrudes from the injection molded connector housing, suggesting that the ingress originated somewhere on the body-side high voltage harness and crept along the conductor eventually making its way into the high voltage battery connector.

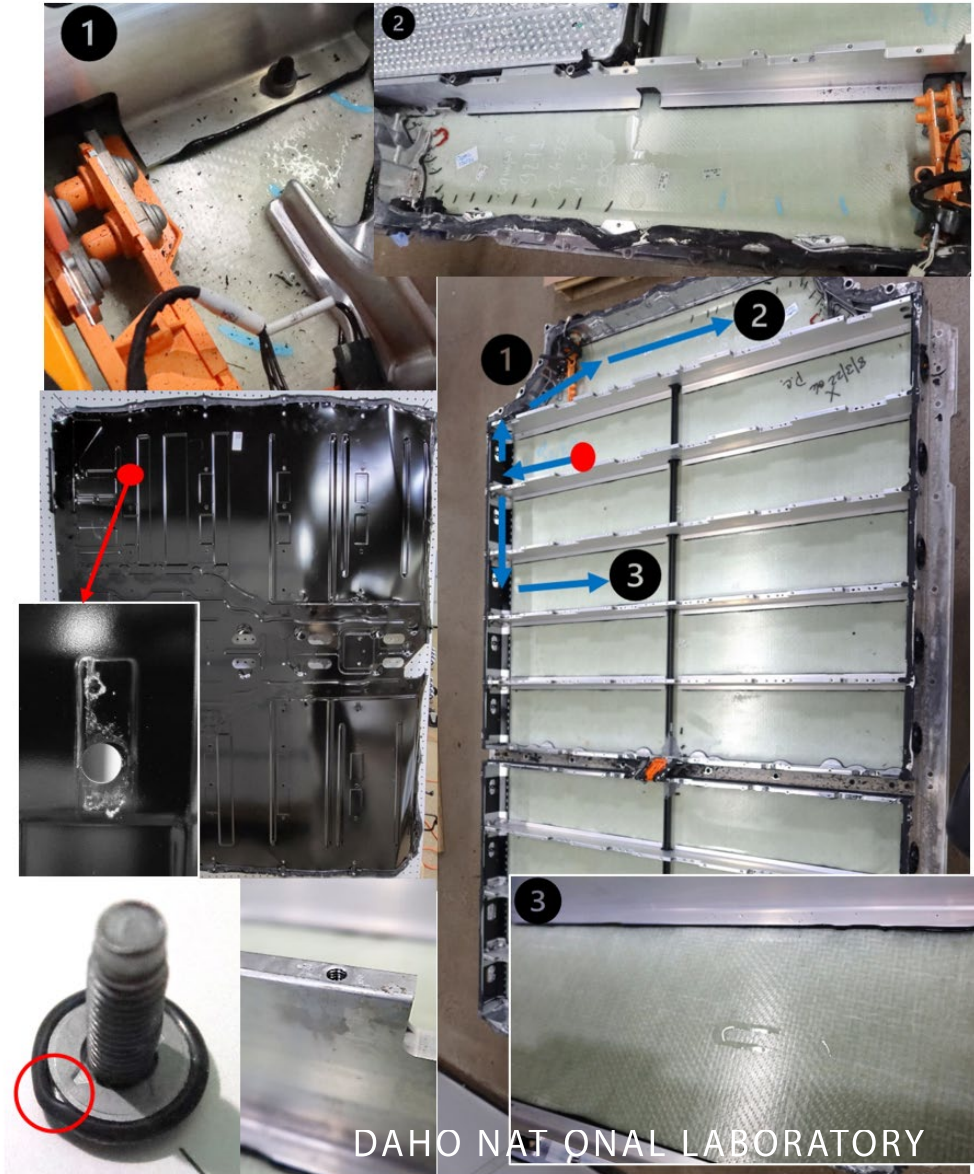
- Upon lid removal, a small amount of standing water was discovered within the front left-hand corner of the pack interior.
- Upon removing the battery modules, additional standing water was observed below two modules:

- Further inspection of the battery tray structure and components revealed no damage, corrosion, or contamination of the battery modules or electronics – however, corrosion and contamination were observed on the lid and tray cross beam around the leak source which was determined to be a compromised lid fastener seal.

- The failed lid fastener seal appears to be a manufacturing issue and not damage caused by the flooding or otherwise.
- Given that the locations of the current collectors on the bottom of the battery modules and they are covered by a polymer sheet but otherwise unsealed from the pack interior, it is reasonable to assume that they are at high risk of shorting should the level of water intrusion reach them (~1 cm).

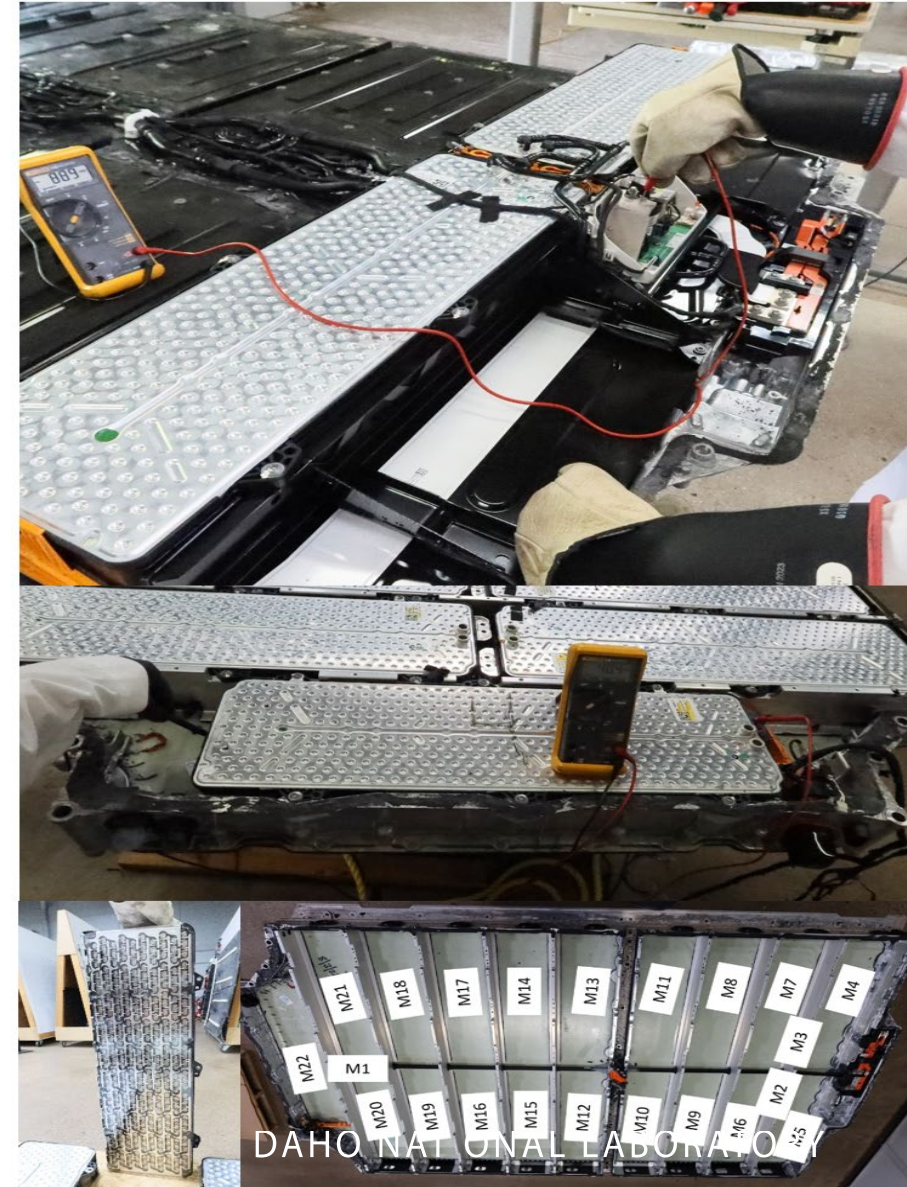
- Pack voltage was measured to be 889V, indicating a nearly full charged state (~91% SOC).
- Module-level voltages were consistent without any variation, indicating that none of the modules had shorted or otherwise been damaged by the water ingress.

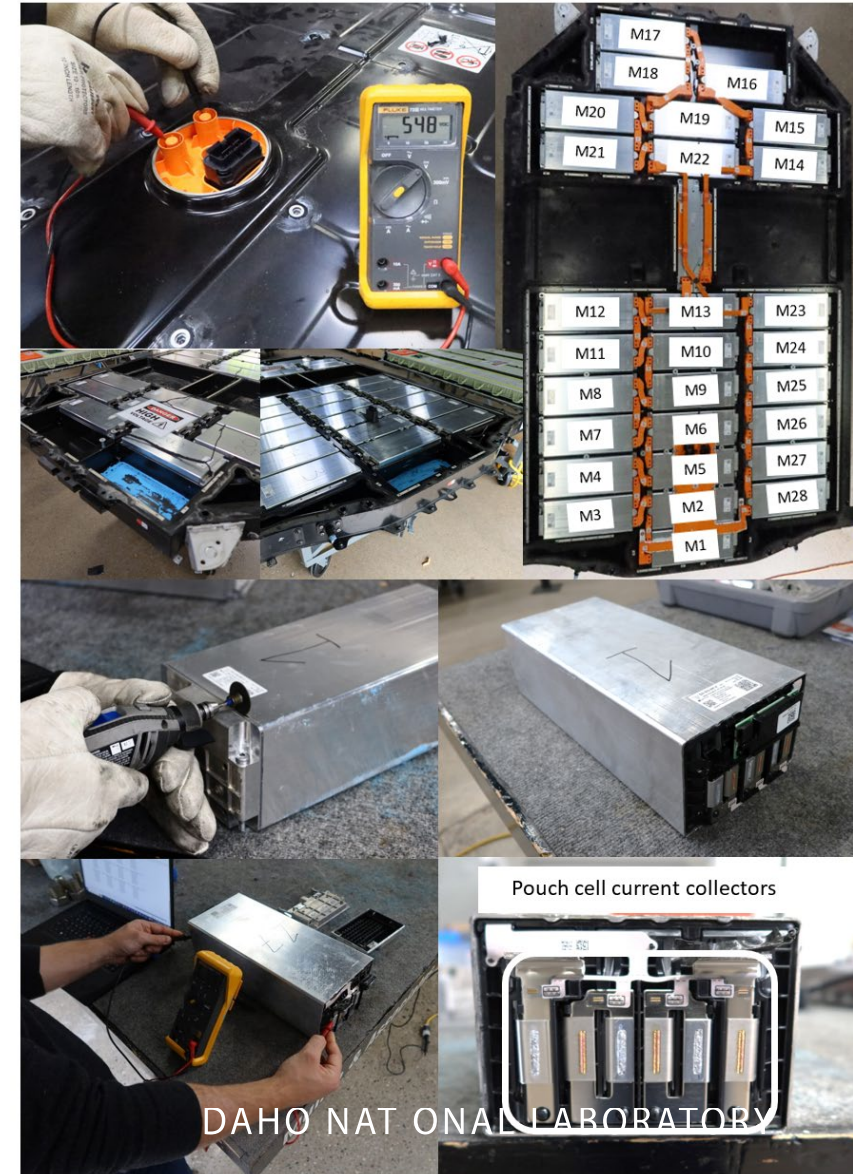
- The vehicle, as received, had photo indication that it had been flooded up to the rocker panel, approximately at the floor-level of the cabin. Physical inspection of the interior and exterior of the vehicle revealed minimal debris or evidence of water, suggesting that the flood line height was insufficient to allow ingress to the cabin interior.
- Visual inspection of the exterior of the HV battery pack confirms that most of the exterior was submersed given the sediment in the second row footwell cavities in the pack, however the penthouse module on the top front of the pack showed no signs of corrosion suggesting that it remained above the flood line.

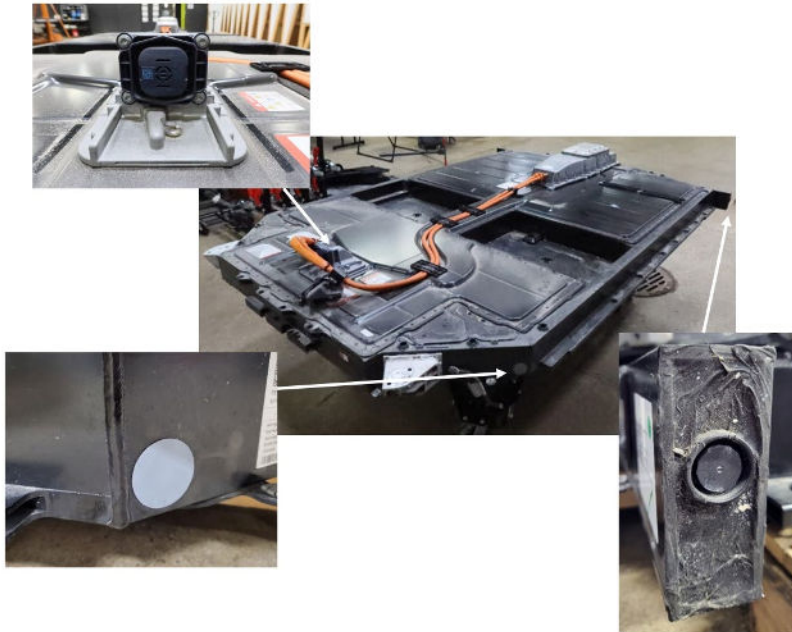
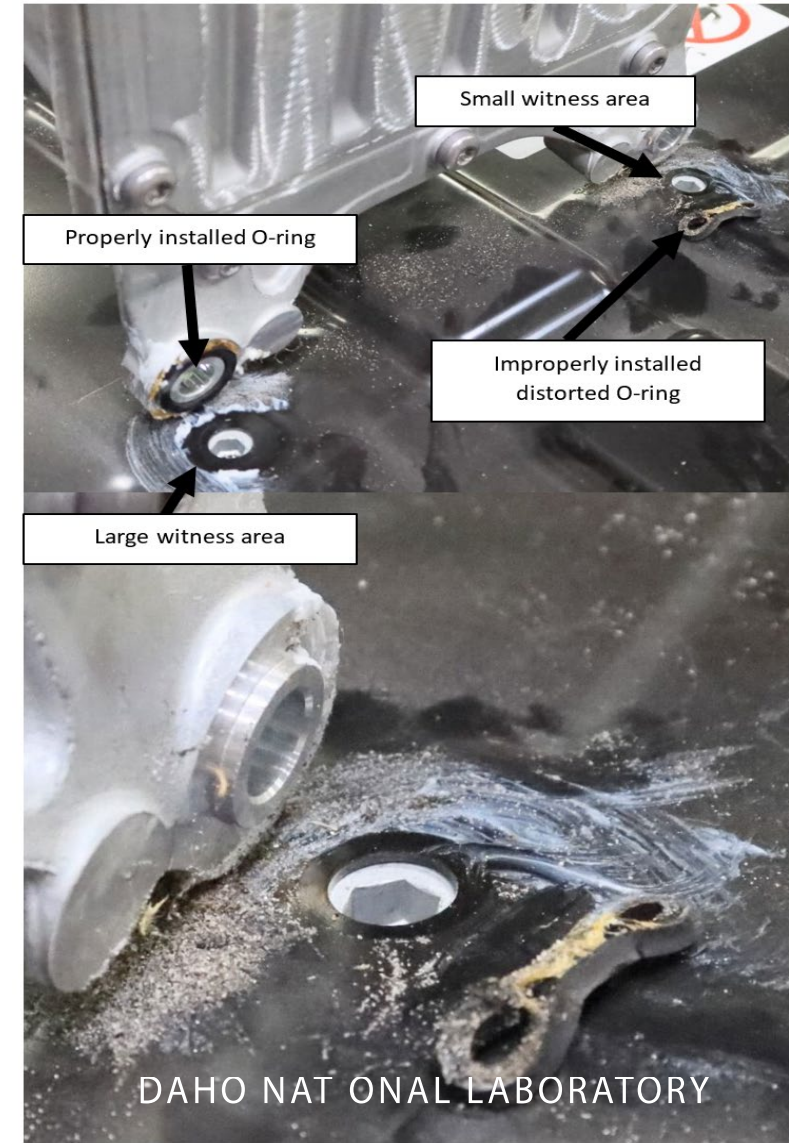
- Inspection of the penthouse upon removal revealed that one of the O-rings was installed improperly, as evidenced by a displaced and crushed O-ring and a small witness area in the grease applied around the compromised O-ring:
  - Although no contamination was observed within the pack interior, it is possible that this could have become a leak path if the submersion had reached above the pack lid for an extended period.
- Vents were uncompromised.

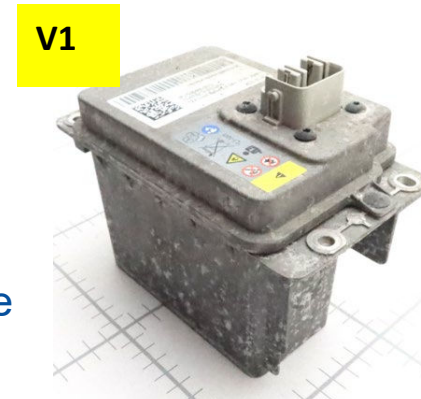
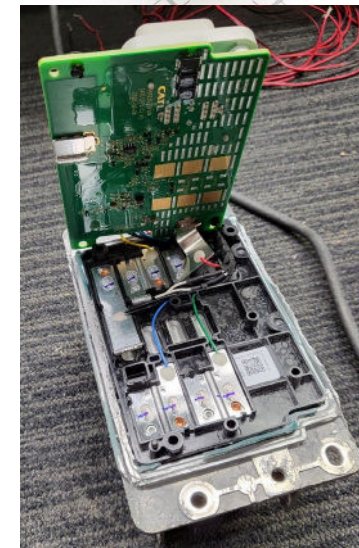
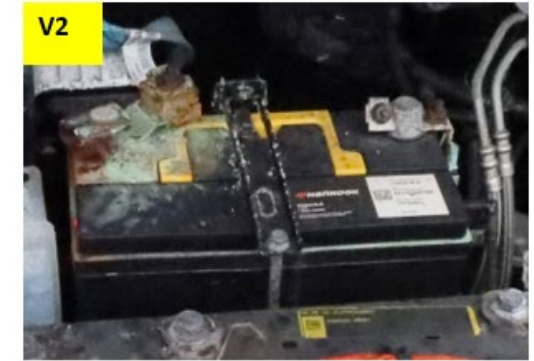
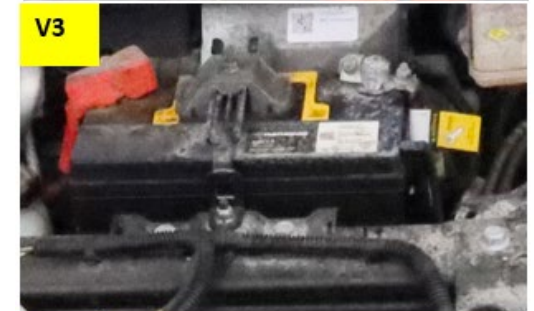
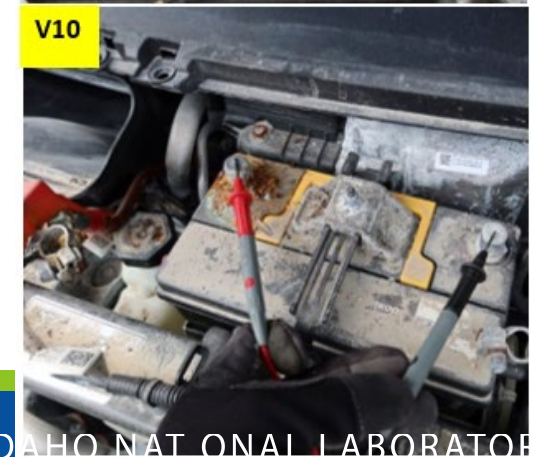
- The 12V battery for this pack design is located under the wiper cowl for this and the other pack designs of Tesla EVs.
- V1 housed a LiB, while the other vehicles had conventional lead acid battery to supply the LV power:
  - The LiB of V1 was at least partially submerged
  - The voltage reading from the main external terminals at the time of removal was 0.026V. The prismatic cell voltages were measured at 0.612V, 0.407V, 0.277V and 0.409V, or 1.7V total
  - The 12V battery interior did not display signs of water ingress suggesting that despite submersion the connector seal was uncompromised.
- Snapshots of the 12V lead acid batteries are presented, which shows evidence (marks, debris, sediment, etc.) of full submersion:
  - The terminals of all these batteries showed heavy corrosion. These low voltage batteries measured ( ~0.05V) to have severely drained.
