Tanvir Tanim, Senior R&D Scientist and Group Lead  
Energy Storage Technology Group, U.S. Department of Energy  
Energy Storage and Electric Transportation

# A Teardown Study of Flood Damaged Electric Vehicles

EV Battery Safety, Part 2

SAE Government/Industry Meeting  
January 16-18, 2024, Washington, DC, USA

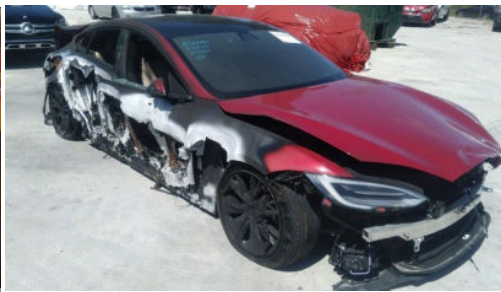
2023 Hurricane Idalia Caused Fire Damaged EV

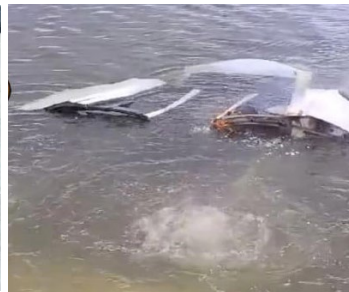
EV burns under water after mishap backing jetski down Florida boat ramp

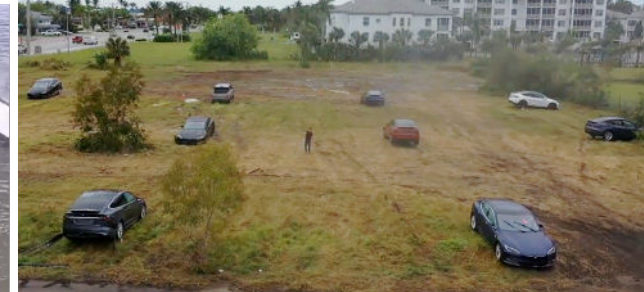
Flood damaged EVs stored 50 ft apart
