Tanvir Tanim, Senior R&D Scientist and Group Lead  
Energy Storage Technology Group, U.S. Department of Energy  
Energy Storage and Electric Transportation

# A Teardown Study of Flood Damaged Electric Vehicles

EV Battery Safety, Part 2

SAE Government/Industry Meeting  
January 16-18, 2024, Washington, DC, USA

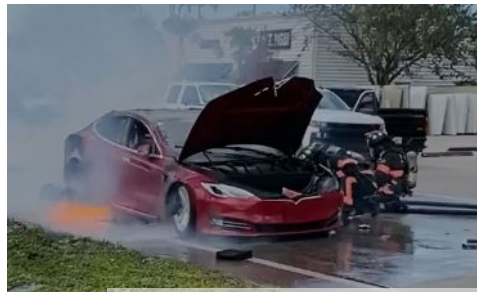
2022 EV Battery Fires at Florida after Hurricane Ian

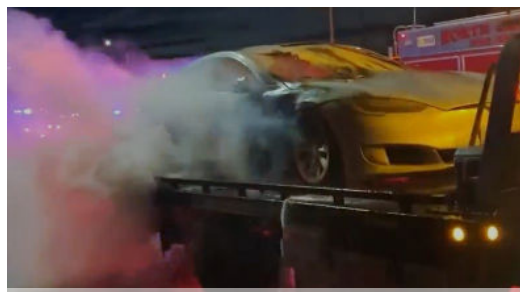
2023 Hurricane Idalia Caused Fire Damaged EV

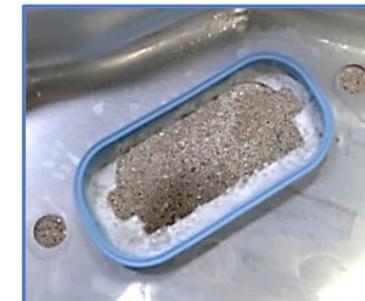
- The exterior side of the penthouse shows signs of submersion resulting in various levels of corrosion for all four EVs in this design group.
- The low voltage DC-DC converter terminals are exposed on the penthouse and as a result exhibited particularly severe corrosion resulting from galvanic activity.
- The underside of the penthouse lid shows what appears to be residue of dried liquid in two distinct areas, which may be indicative of either condensation or some level of water ingress in V1 and V2.
- Those areas are surrounding or adjacent to the penthouse breather vent and low voltage communication connector.
  - The interior surroundings of the low voltage connector opening (silicone seal) in V2 shows witness marks.
